Inspection Report

Property Address:
223344 NE 33rd Street
Bend OR 97701

Hero Home Inspector

Date: 5/4/15	Time: 10:00	Report ID:
Property: 223344 NE 33rd Street Bend OR 97701	Customer: Mr. John Smith	Real Estate Professional: Pro Agent wesellhouses

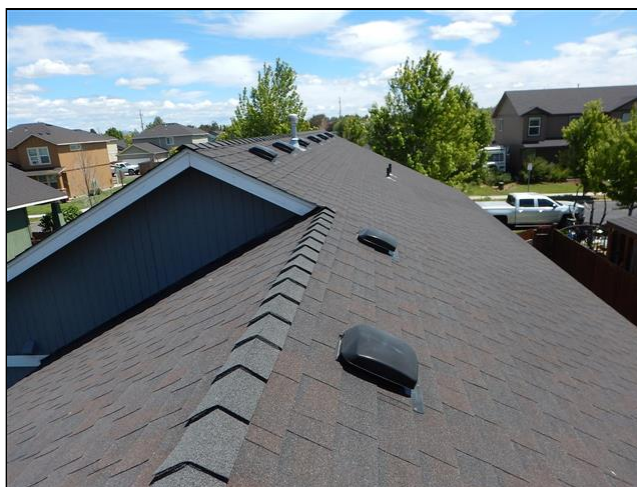
D. Item 1(Picture)

View of roof and vents.

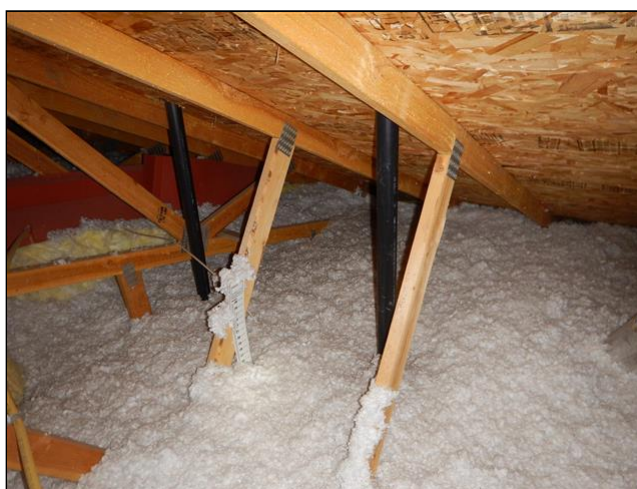
H. Item 1(Picture)

Comments:
 View of attic insulation.

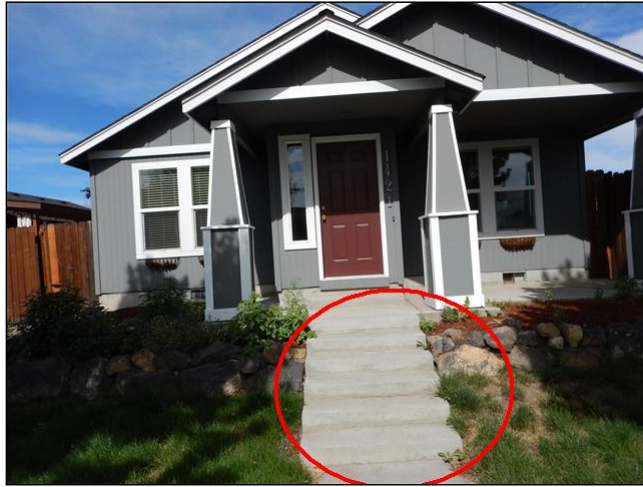
D. Item 1(Picture)

The hand/guard rail for the front steps missing. A fall or injury could occur if not corrected. A handrail should be installed for safety.

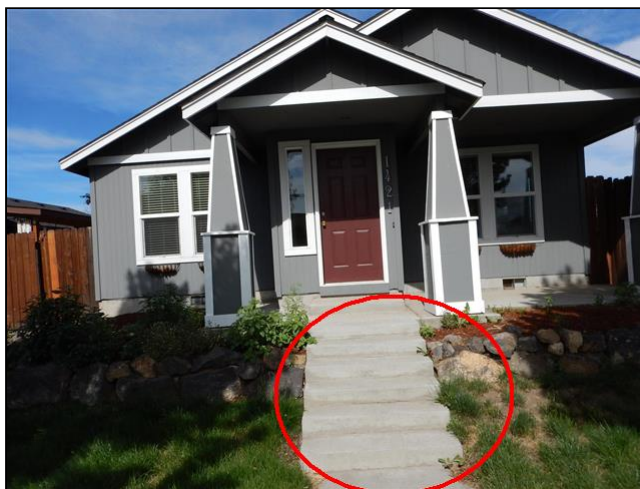
Item 4 - Item 1(Picture)

- 4. The hand/guard rail for the front steps missing. A fall or injury could occur if not corrected. A handrail should be installed for safety.

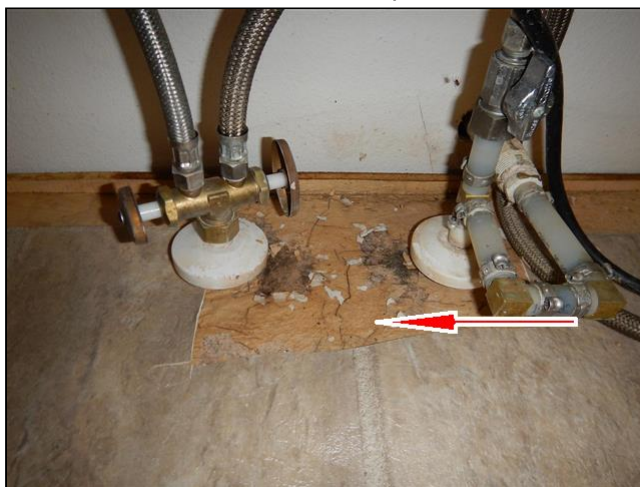
Item 6 - Item 1(Picture)

6. The faucet leaks at the kitchen sink. Repairs are needed to stop leaking water from damaging the cabinet bottom or to eliminate moisture that may contribute to fungi growth. I recommend repair as necessary by a qualified person. There is evidence of water leakage under the kitchen sink and in the crawlspace.
